ANALYTICAL SCIENCES

Sample Report / Brittle Paint

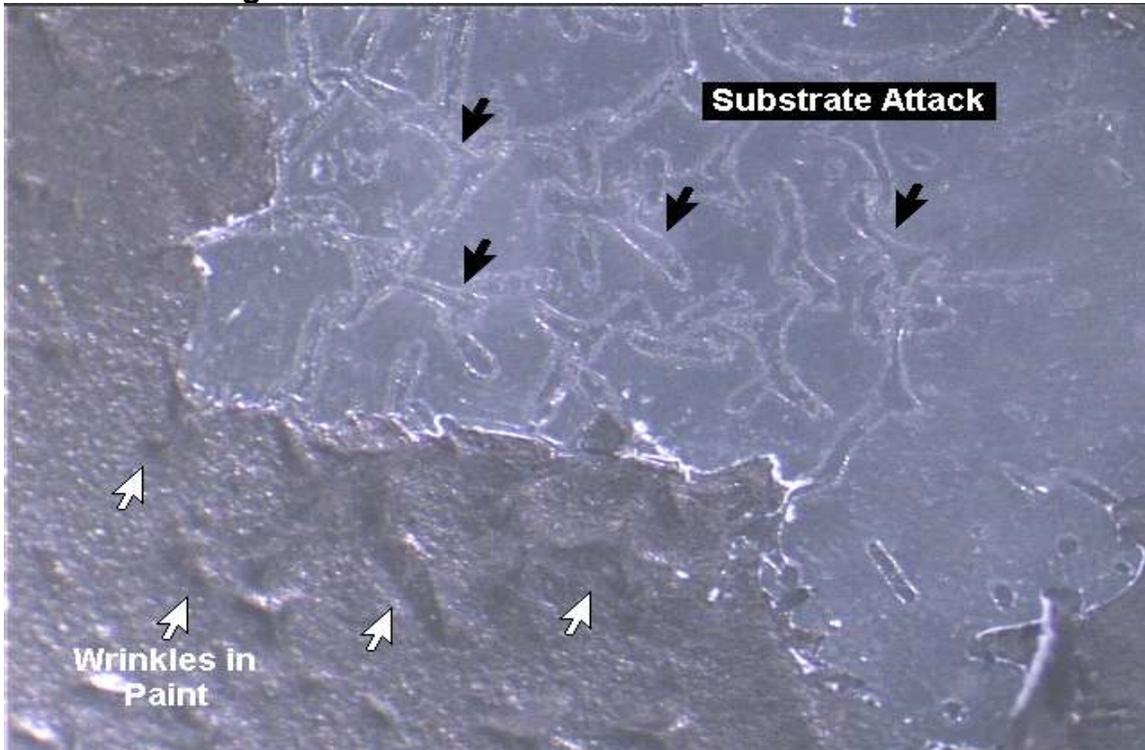
Figure 1 – Possible Solvent Attack on Button

Secondly, the substrate has been attacked by what could be unflashed or inadequately baked out solvent. The marks on the substrate mirror wrinkle marks on the paint.

Results and Discussion: Microscopic examination of the button showed signs of substrate attack below the failed paint. Inherent groove patterns coincide with wrinkles seen on the coating. They may have been caused by unflashed solvent from the paint. Figure 1 below illustrates this condition.

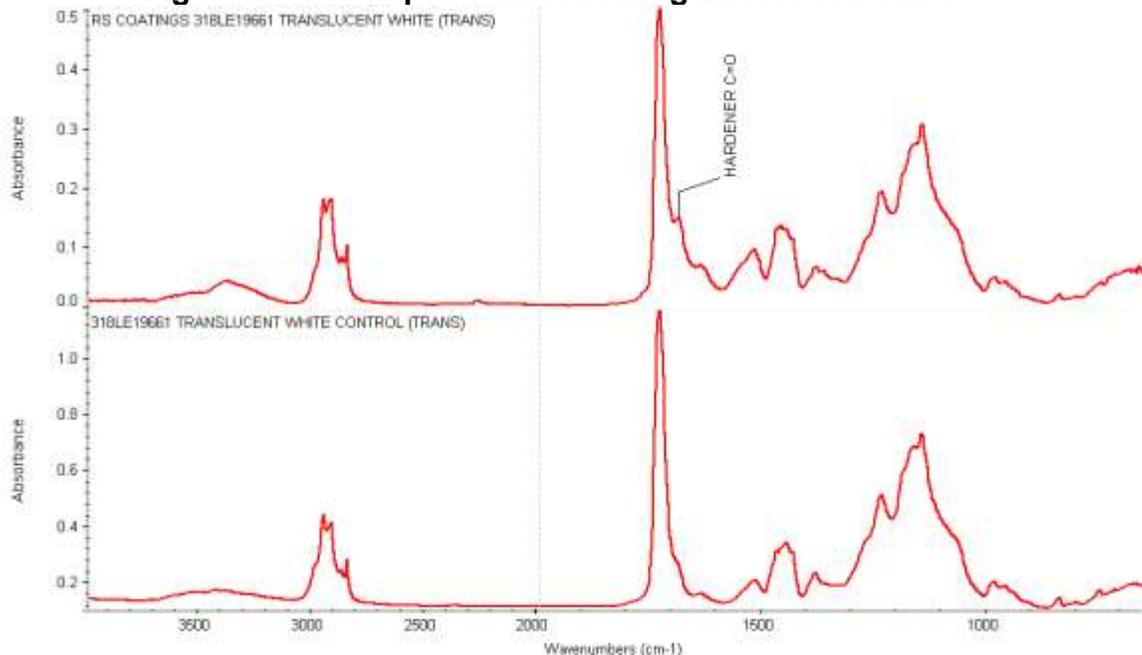
Figure 2 – FTIR Spectrum Indicating Excess Hardener

Fourier transform infrared spectroscopic analysis (FTIR) of the Translucent White coating from the button showed approximately twice the level of hardener present, when compared to a control. Figure 2 below shows the two spectra, with the hardener absorption labeled. Its concentration is indicated by the peak height of the carbon/oxygen double bond (C=O) functionality, as indicated on the spectrum. The absorption from the button paint is approximately twice that of the control's. The paint would remain uncured until the hardener eventually reacted with moisture from the atmosphere. The black and ebony also appear to have elevated hardener levels.

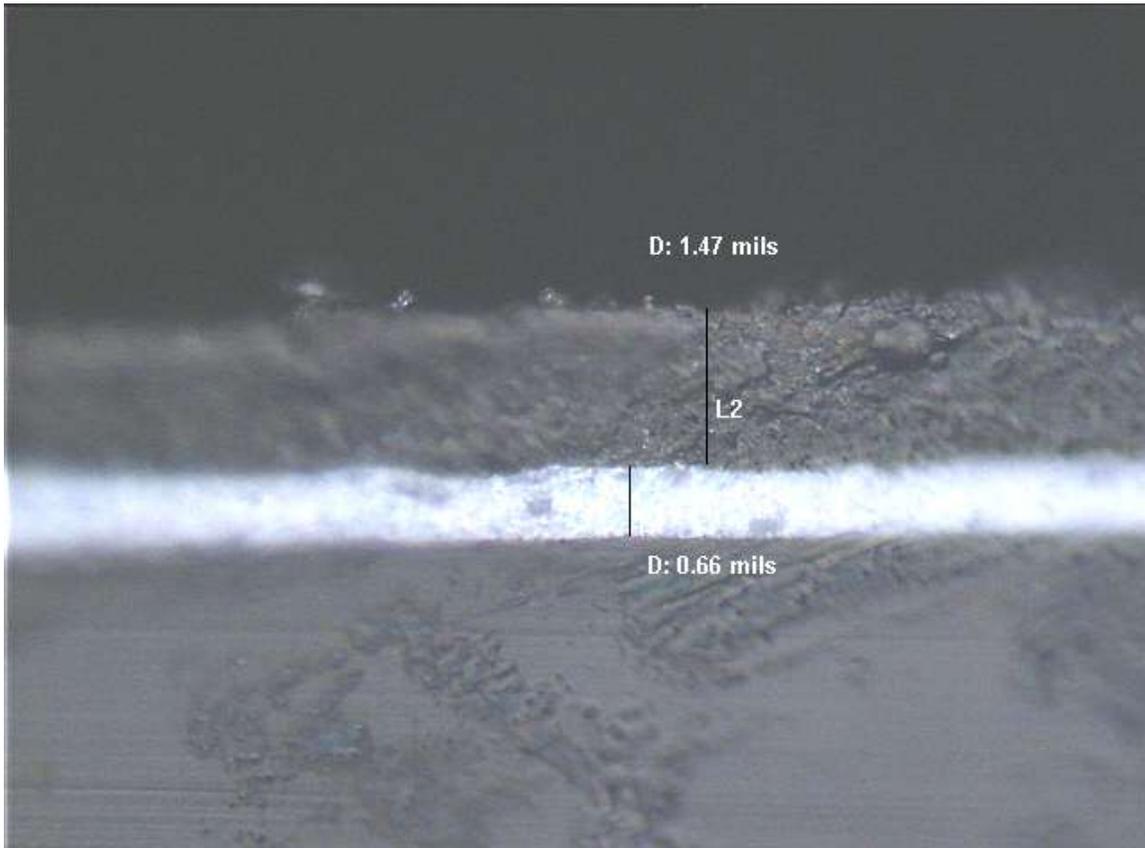
Figure 3 – Coating DFT's of Button from Cross-Section

Dry film thicknesses of the button coatings were checked by optical microscopy combined with Pax-It image analysis software. This showed the white somewhat low at 0.66 mils. The DFT's of the individual black and ebony was not determined because of insufficient contrast. Their combined thickness is 1.47 mils as shown in Figure 3 below.
